Implementation of arc flash mitigating solutions at industrial manufacturing facilities

David B. Durocher
Senior Member, IEEE
Global Industry Manager
Eaton
26850 SW Kinsman Road
Wilsonville, OR 97070 USA
davidbdurocher@eaton.com

Abstract

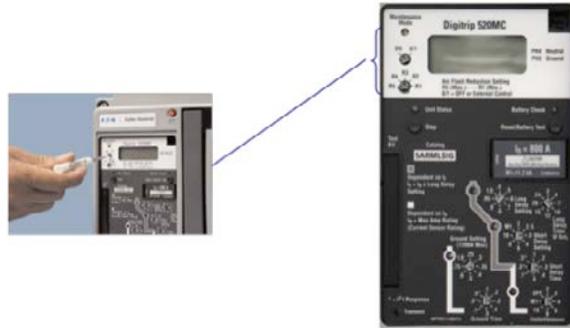
Figure 6
Air circuit breaker included an integral trip unit with Arcflash Reduction Maintenance System (ARMS) capabilities.

Figure 6 shows the typical integral trip unit of the air circuit breaker and the ARMS or maintenance setting. Local and remote enabling and indication capabilities are provided, allowing consideration for Lock-out/Tag-out procedures from outside the arc flash hazard area.

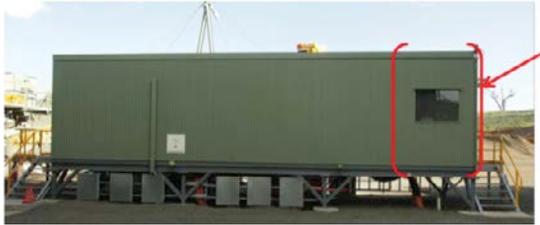
Airlock Room Segregated from Main Switchroom

Figure 8
The main switchroom is designed with an airlock section where the ARMS switch and confirming indicating light are mounted. This functionality is activated prior to maintenance persons gaining access to the main switchboard area.

To ensure an additional level of safety, the design of the main switchroom included an airlock section as shown in **Figure 8**. The airlock room is physically isolated outside of the main switchroom where the switchboard is located. An ARMS activation switch and remote maintenance mode indication light is located in the airlock room. In addition, motion detectors were installed inside the main switchroom that also engaged the maintenance mode. This was a back-up safeguard in the event the ARMS switch was mistakenly not engaged by the operators or perhaps non-qualified persons who somehow have access to this space. Indication of the ARMS mode also is connected to the SCADA system so plant operators were aware of the setting.

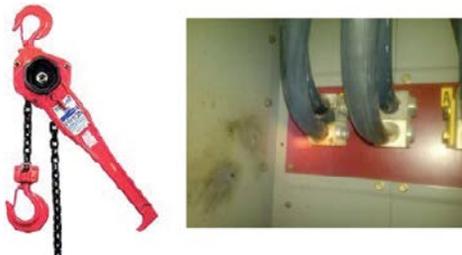
Figure 11
At left, a “come along” tool used for energized work and at right, damage to panel after phase to ground arc flash event with an upstream device with maintenance setting capabilities.

The event caused the entire plant to shut down, stopping work on the project until an analysis could be completed. It was determined that the chain of the come along had drifted below where the work was being performed and into energized Cubicle 4. Fortunately, the damage to the wall of the switchgear and come along tool was minimal, which is shown in **Figure 11**. Post event analysis proved that the chain of the come along had drifted below where the work was being performed and into an energized cubicle. The chain touched an energized terminal and arced to ground, touching both phase conductor and cabinet ground metal below the non-energized cubicle where the electrician was working. After reviewing minimal damage and completing the project while de-energized, the plant switchgear was cleaned and re-energized. Fortunately, total downtime for the plant due to this event was minimal. No loss of equipment or injury to any employee was a result of this event.

The important take-away here is that the arc flash study was completed before energized work was performed. The upstream low voltage power circuit breaker with the special maintenance switch setting discussed previously employed technology to clear the fault faster than the microprocessor instantaneous setting of the circuit breaker trip unit. Calculations were previously performed that quantified a reduction in incident energy from 17.7 cal/cm² to 2.9 cal/cm² using the special maintenance setting. Both workers and equipment were saved as a result of a total clearing time at 40 milliseconds as defined by the manufacturer's published trip curves^[8].

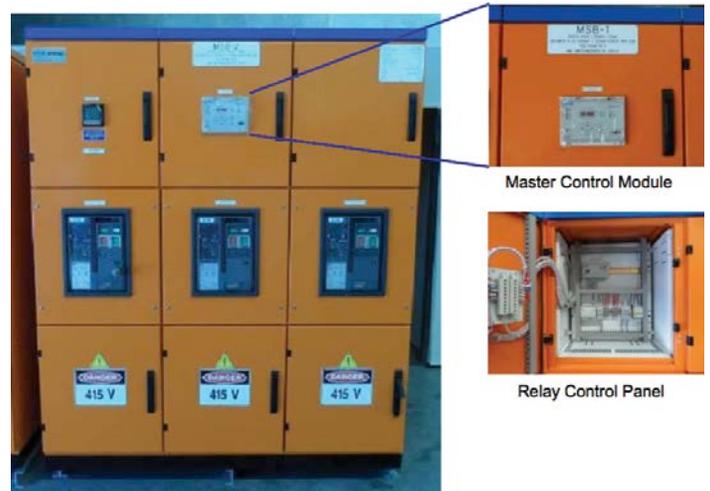
Replacement 415 volt switchboard with light detection and quenching device installed. The Master Control Module offers complete system controls and MMI display.

Figure 14 shows one of the new low voltage MCCs on the factory assembly floor prior to witness tests. Note that the panel at the left includes an incoming power meter to record energy use. The center panel includes a master control module where the light detecting sensors are connected. In the event of an arc flash, the sensors will initiate a trip signal to the quenching device which is connected at the main bus at the load side of the incoming main circuit breaker. The master controller also captures information regarding which sensor recorded the flash so the location of the arc can easily be traced after the fault is cleared. Note that this low voltage MCC is comprised strictly on air circuit breakers, with two feeder breakers that protect downstream equipment. In this application, including the maintenance switch capability to assure faster total clearing times when personnel are working in downstream equipment would also represent a best practice in mitigating potential arc flash hazards.
